Storm Water Construction General Permit Inspection Report

RWQCB - Region 5S

Pine Grove Bluffs

1/13/2009

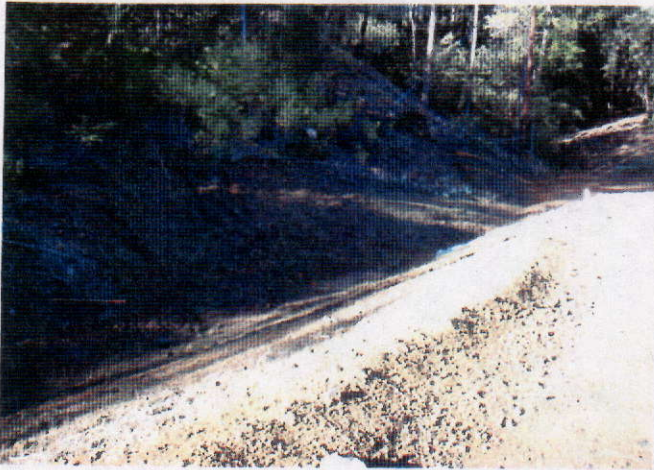
Figure 1: Area on the construction site that has not been effectively stabilized

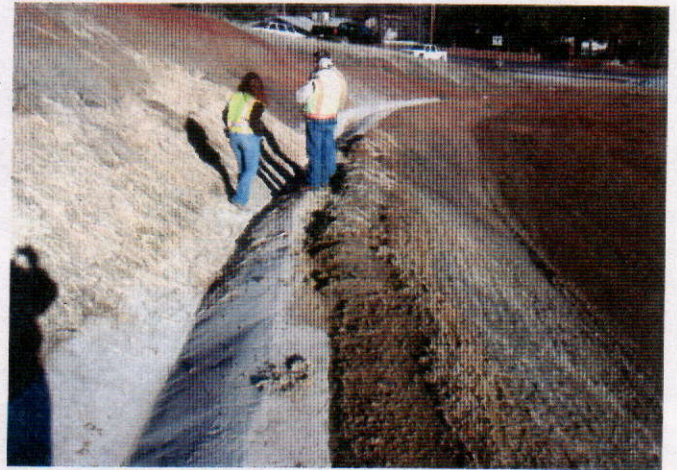
Figure 2: Erosion on the steep cut slope on the development

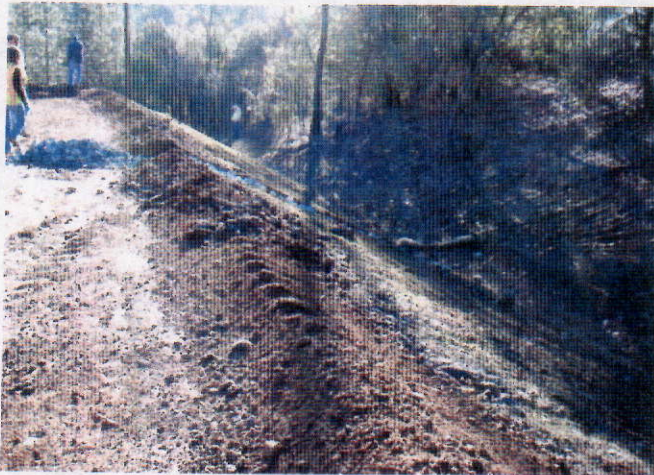
Figure 3: Another area that is poorly protected

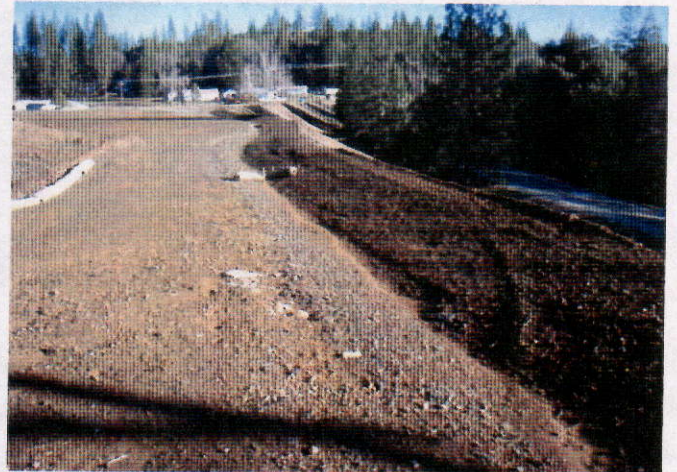
Figure 4: Lack of an effective combination of erosion and sediment control BMPs

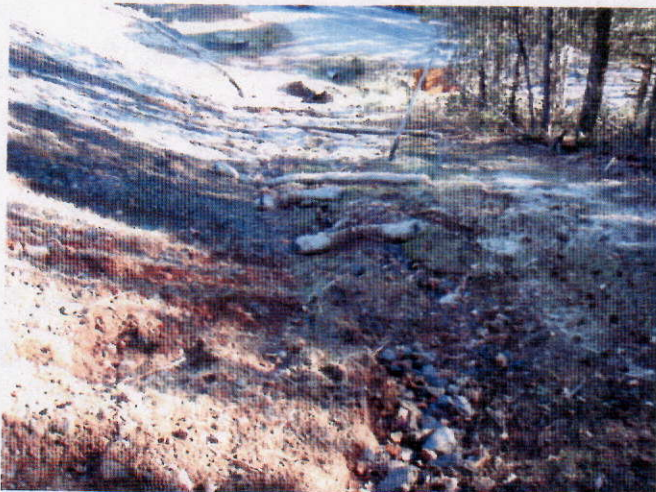
Figure 5: Poorly installed and maintained BMPs

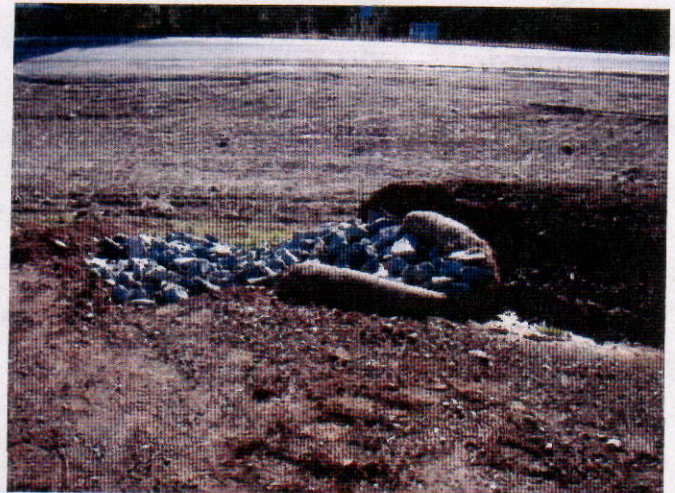
Figure 6: Another poorly installed and maintained BMP

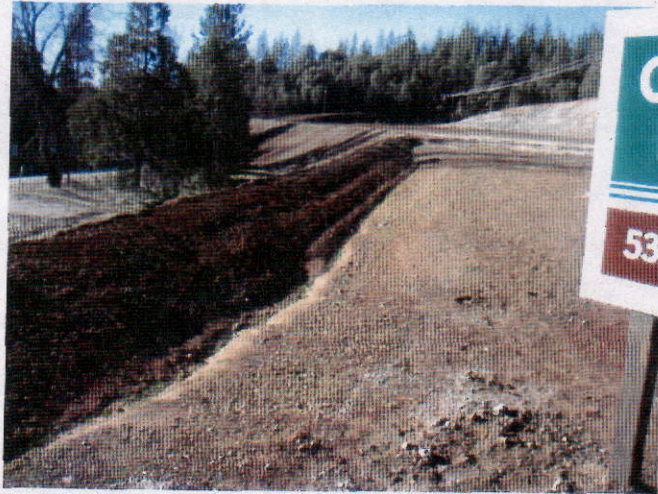
Figure 7: Lack of an effective combination of erosion and sediment control BMPs

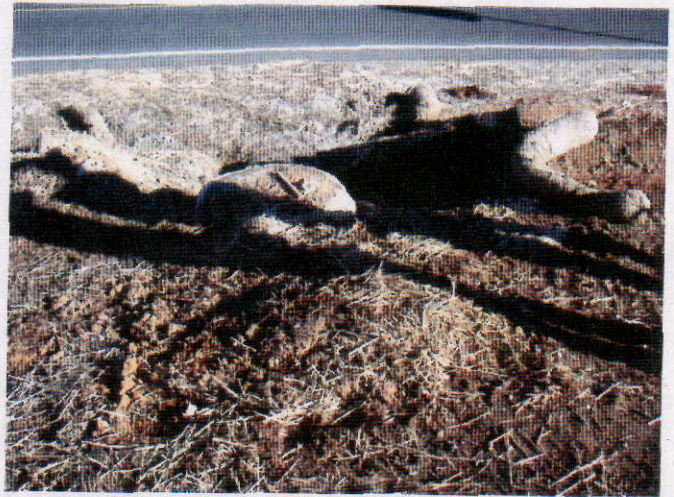
Figure 8: Poorly protected drain inlet

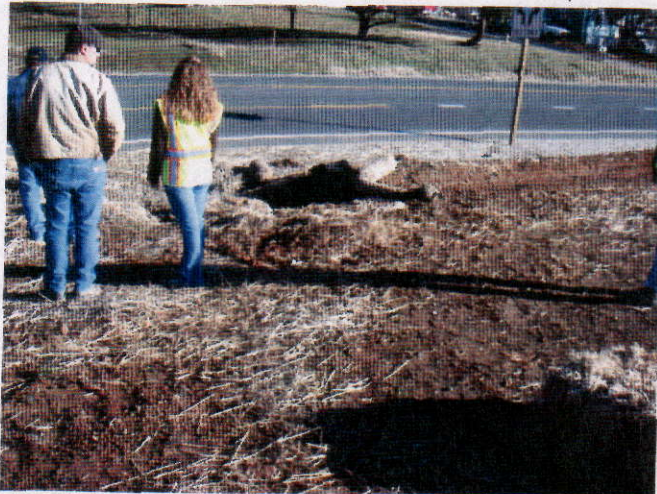
Figure 9: Another view of the poorly protected drain inlet

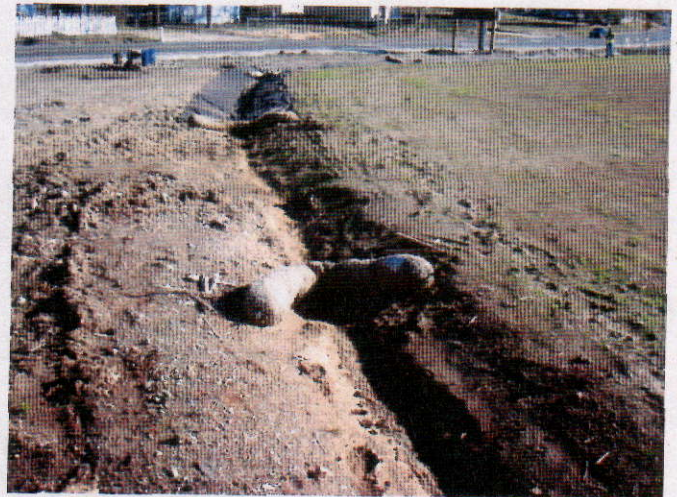
Figure 10: Poorly installed and maintained BMPs
